IMPROPER Set Loading

for the Medley™ Pump Module

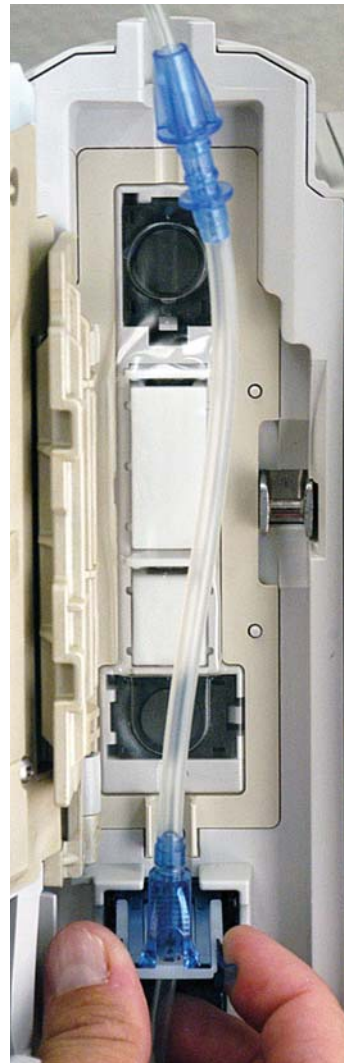
The Flo-Stop® fitment should never be placed into the Medley™ Pump Module prior to inserting the upper fitment.

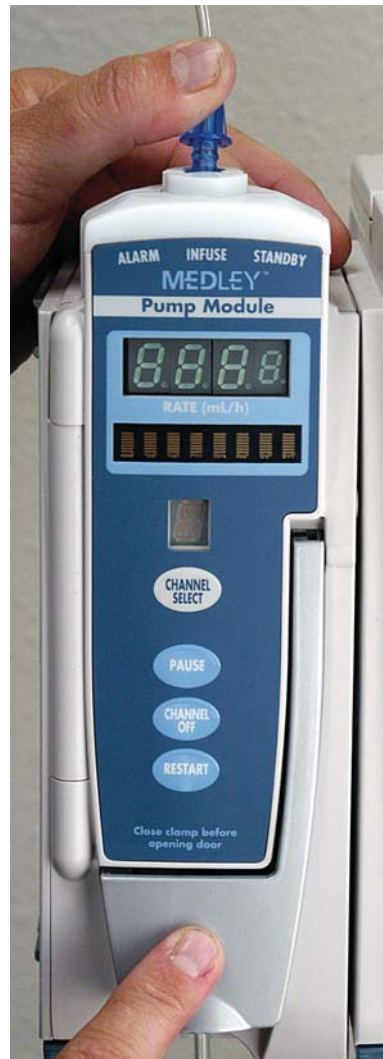
Do Not Touch the set upper fitment while closing and latching the door.

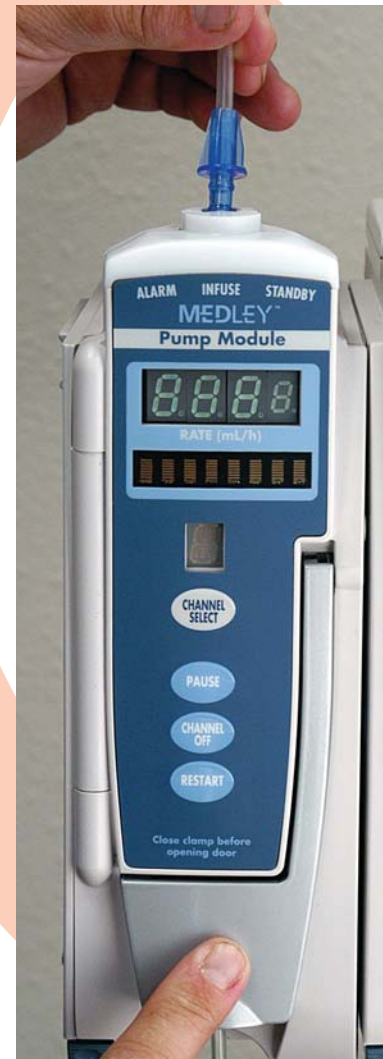
Do Not Hold the tubing while closing and latching the door.

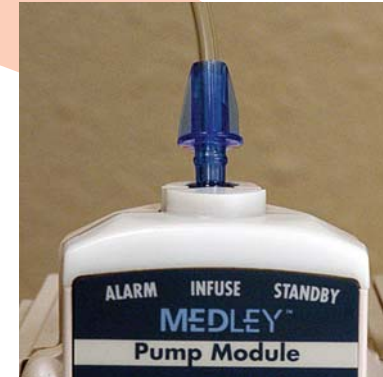
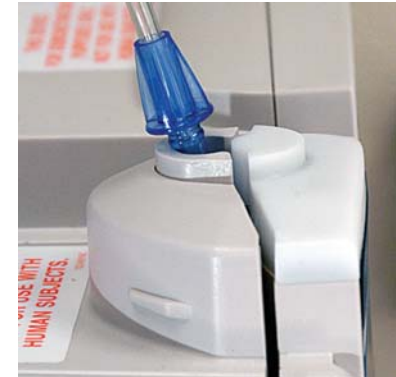
In this illustration, the upper fitment is tilted from the vertical. It was likely caused by applying lateral force to the upper fitment while closing and latching the door. If the set is loaded in this manner you may experience infusion rate inaccuracy.

If You Observe Any of These Conditions, Close The Roller Clamp and Reload The Set Upper Fitment into The Receptacle

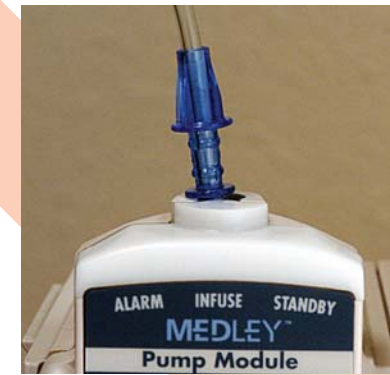
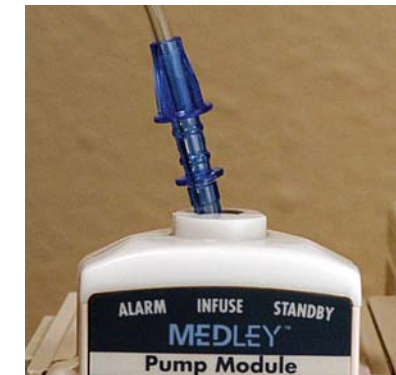
In these illustrations, the upper fitment is elevated above the receptacle on the Medley™ Pump Module. It was likely caused by maintaining traction on the set while closing and latching the door. If the set is loaded in this manner you may experience infusion rate inaccuracy.

If You Observe Any of These Conditions, Close The Roller Clamp and Reload The Set Upper Fitment into The Receptacle
